DOE/NASA/20320-63
NASA TM-86983

Government Review of the Mod-2 Wind Turbine (As-Built)

June 1985

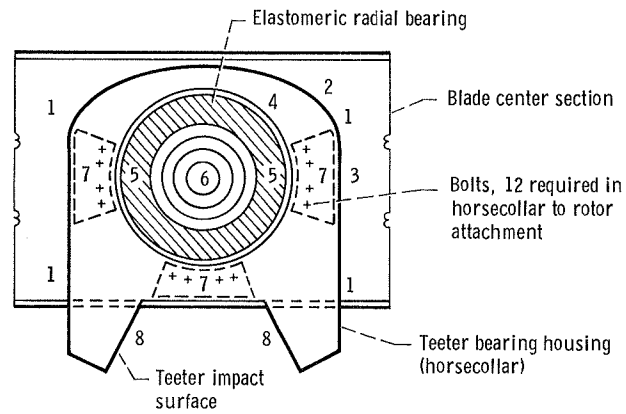
Figure 5. - Teeter bearing housing.

- (1) Iron oxide stains, indicating fretting at the horsecollar-to-rotor spar interface, were observed at location 1, figure 5, on all five Mod-2's.
- (2) Evidence of plastic shim failure was observed at location 7, figure 5, on WT4 and WT5.

- (3) Poor fit up (gap) at horsecollar-to-rotor spar interface was observed at location 3, figure 5, on WT5.
- (4) Weld flaws were observed at location 4, figure 5, on WT4; and a possible weld crack at the same location on WT2.

- (5) Surface cracks were observed on the elastomeric radial bearing at location 5, figure 5, on WT4.
- (6) A gap was observed at location 6, (see fig. 5) on WT4 between the elastomeric thrust bearing and rotor spar for the lower thrust bearing with the rotor horizontal, indicating a significant reduction in preload.

- (8) Evidence of high teeter-stop loads at location 8, figure 5, were observed on WT5. This was presumably a result of nonoperating rotor-teeter motion in winds above cut-out velocity.

- (1) Design, fabricate, and install a teeter motion damper
- (2) Replace plastic shim between horsecollar and rotor with steel shim
- (3) Determine cause of loss of preload in thrust bearing and take corrective action

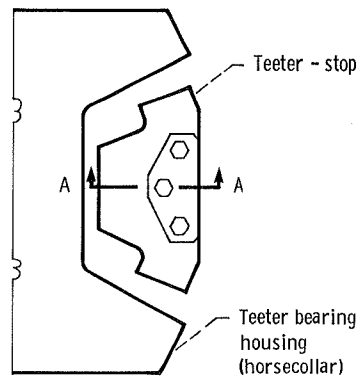
(View A-A)
Figure 6. - Teeter-stop details.

(3) The steel teeter stop was torn and galled. The bolts used to fasten the teeter-stop to the teeter-stop support structure showed evidence of being loose.

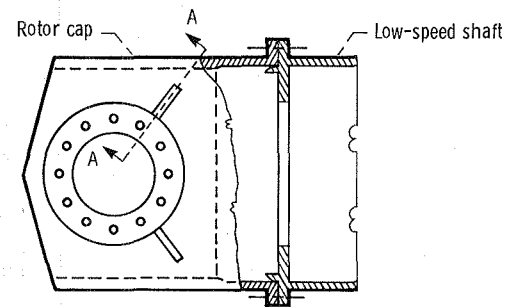
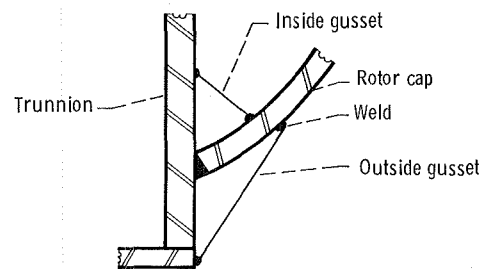
(View A-A)
Figure 7. - Rotor cap details.

- (1) Evidence of corrosion at the rotor cap trunnion and teeter bearing interface, was found on the WT4 and WT5.

(2) Evidence of motion at the thrust bearing and teeter bearing interface was observed on WT5.

(3) Cracked paint and evidence of corrosion on the gussets of WT2 was found. Also, poor weld quality at the ends of the gussets was noted on WT4.

- (a) Wrench marks in the flange fillet radius of the rotor cap on WT1
- (b) Machine marks in the flange bolt holes on WT1
- (c) Evidence of fretting corrosion at the flange joint interface on WT5

Rotor cap part	Fatigue performance (hr before repair)
Trunnion and teeter bearing pilot ring	4700
Trunnion and teeter bearing bolts	19 after failure of pilot ring
Welded gusset	400
Intersection weld trunnion	3300

A critical structural area is the trunnion-to-elastomeric bearing interface. If the pilot ring fails to carry the interface loads, the bolts at the trunnion-to-elastomeric bearing interface will carry the load for an estimated 19 hr. The potential advantage of increasing the diameter of these bolts was not analyzed. Further analysis is needed to determine if larger bolts are desirable and practical. Methods for strengthening the pilot ring should be considered. Installation of a close tolerance backup ring is one possible method for increasing the fatigue performance of the pilot ring. Another approach is to investigate inserting steel dowel pins between the bolts.

The BEC analysis of the rotor cap shows negative margins of safety for limit loads applied to certain portions of the rotor cap. This particular load condition accounted for teeter "banging" that occurred when the rotor was stopped and subjected to high winds. All negative margins can be eliminated by the installation of an effective rotor-teeter damper. The teeter damper should substantially reduce the high impact type loads currently being absorbed by the rotor cap.

- (1) Increase bolt size and preload at low-speed shaft-to-rotor cap interface
- (2) Install additional gusset plates, as required, at trunnion and rotor cap intersection weld
- (3) Repair or redesign pilot interface
- (4) Grind fillet weld wrench marks and increase washer thickness to provide adequate clearance

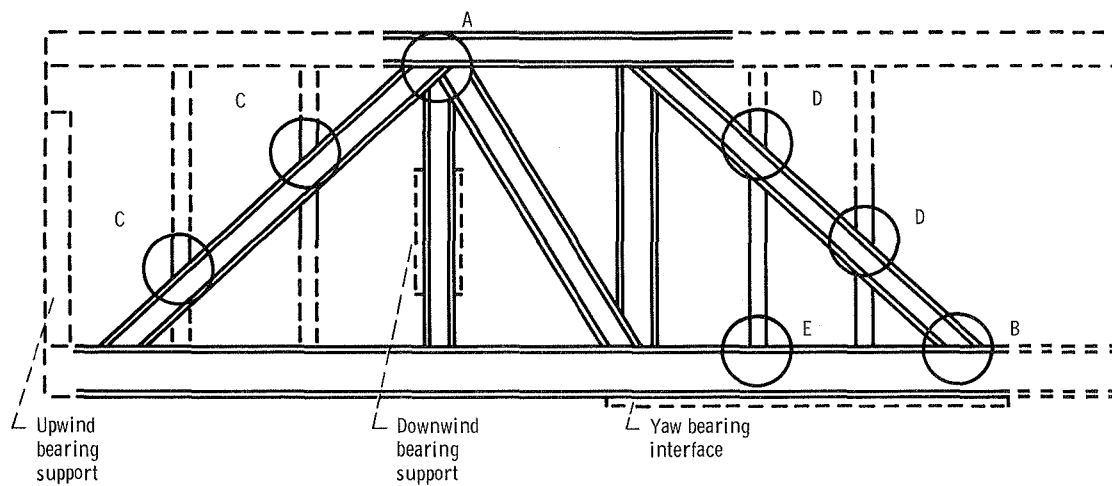
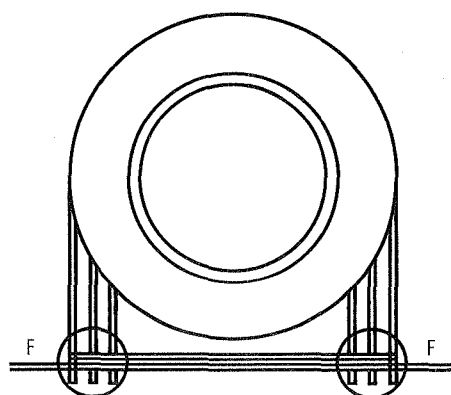
Figure 8. - Nacelle and major bearing support details.

A visual inspection of critical weld areas in the nacelle did not identify any failures. The fatigue analysis estimated "time to repair" values varying from 6 mo to 10 yr as shown in figure 8. The analysis was based on the assumptions listed in appendix D.

Area	Est. time until repair, hr
A	67 000
B	57 000
C	60 000
D	16 000
E	20 000
F	4 000

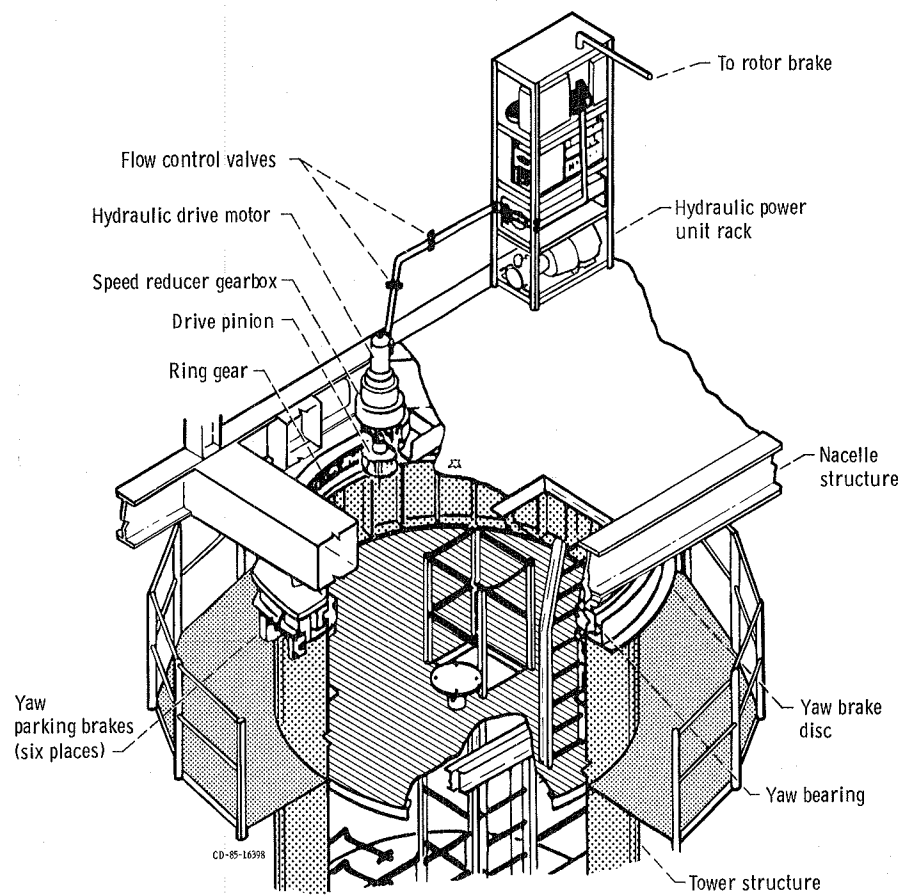
Figure 9. - Yaw drive system.

Of all the components examined during the Government inspection of the Goldendale site, the yaw drive system showed the most obvious signs of damage and improper installation. Examination of the ring gear showed yielding and wear of the teeth over a sector of about 25°. Because of the predominant directionality of the winds at this site, the pinion works the ring gear over a relatively small sector most of the time. Alignment between the pinion and ring gear was such that contact between these two gears was maintained along only about one-third of the tooth width. The manufacturer of these gears recommends a minimum of 85 percent tooth surface contact. BEC measured backlash values between pinion and ring gear as large as 0.110 in. The manufacturer recommends backlash of 0.023-in minimum to 0.044-in maximum.

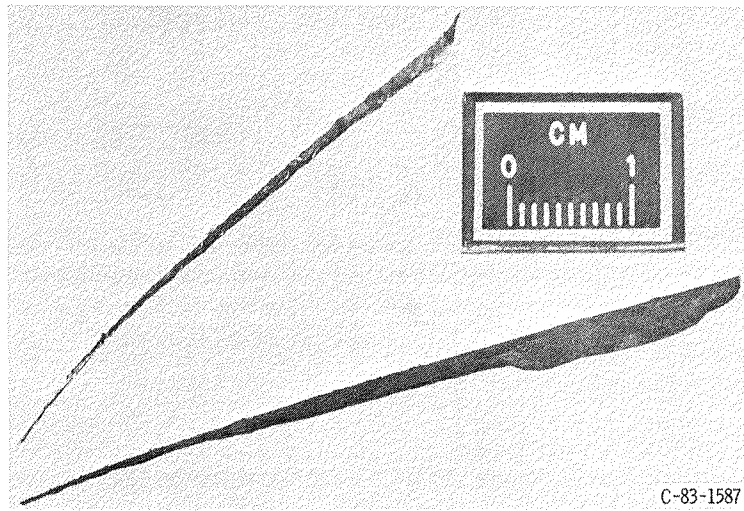
Figure 10. - Metal slivers removed from yaw ring gear.

The pinion gear specification calls for heat treatment to BHN 350/425. The ring gear specification calls for heat treatment to BHN 250/300. With the pinion gear having the harder surface, alignment and tooth surface contact become very important. Without proper alignment and tooth contact, excessive wear and possible tooth breakage can occur. Slivers of metal, as shown in figure 10, were removed from one ring gear.

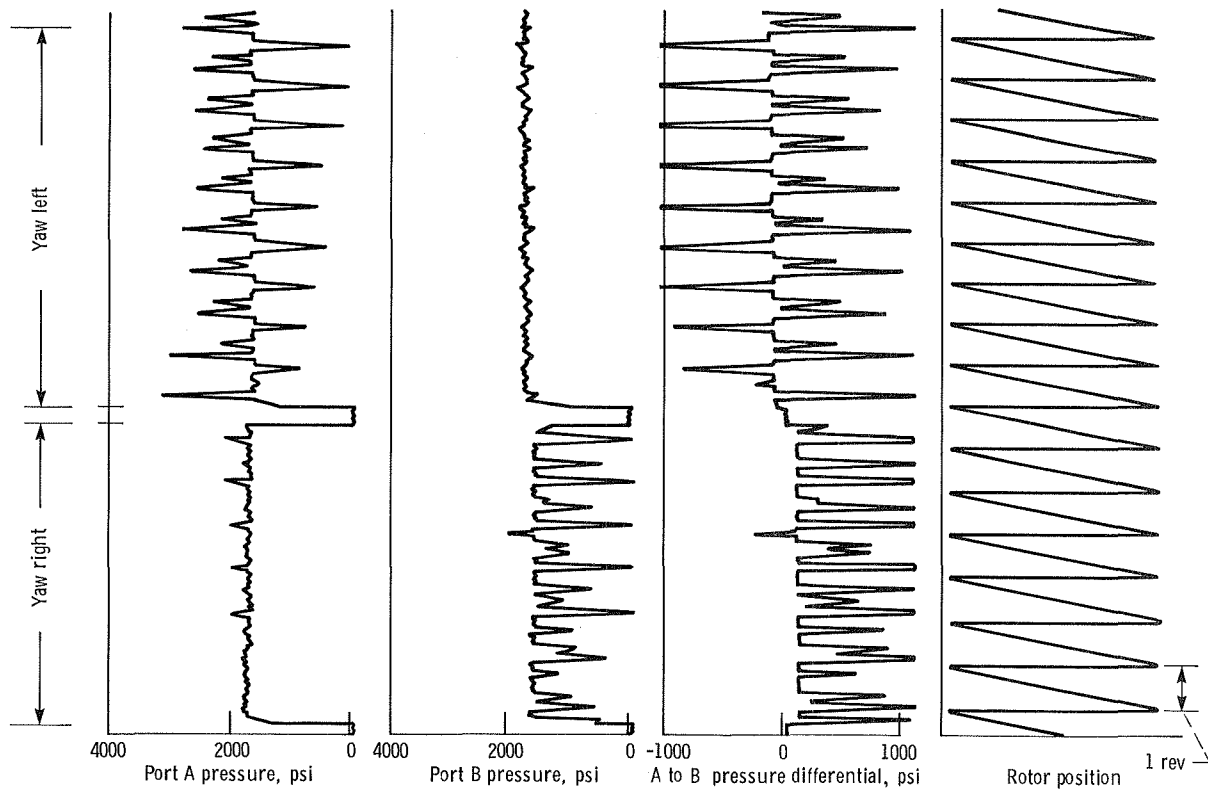
Figure 11. - Yaw drive motor pressures during yaw corrections. (Rotor speed = 17.5 rpm.)

During Mod-2 operation, just prior to the low-speed shaft failure, measurements of hydraulic pressure at the yaw drive motor ports were made. These measurements, shown in figure 11, showed pressure impulses of close to 2000 psi (system design pressure) when yawing took place while the rotor was at normal operating speed (17.5 rpm). If yawing took place when the rotor was coming up to operating speed, higher peak impulse pressures were observed. The impulsive nature of the pressure measurements is a result of the cyclic yawing moments produced by the rotor and backlash in the gear teeth. Because of the backlash, the nacelle can rotate through a small angle unrestrained except for friction in the yaw bearing. This motion continues until the ring gear impacts the pinion gear causing a pressure spike in the drive motor.

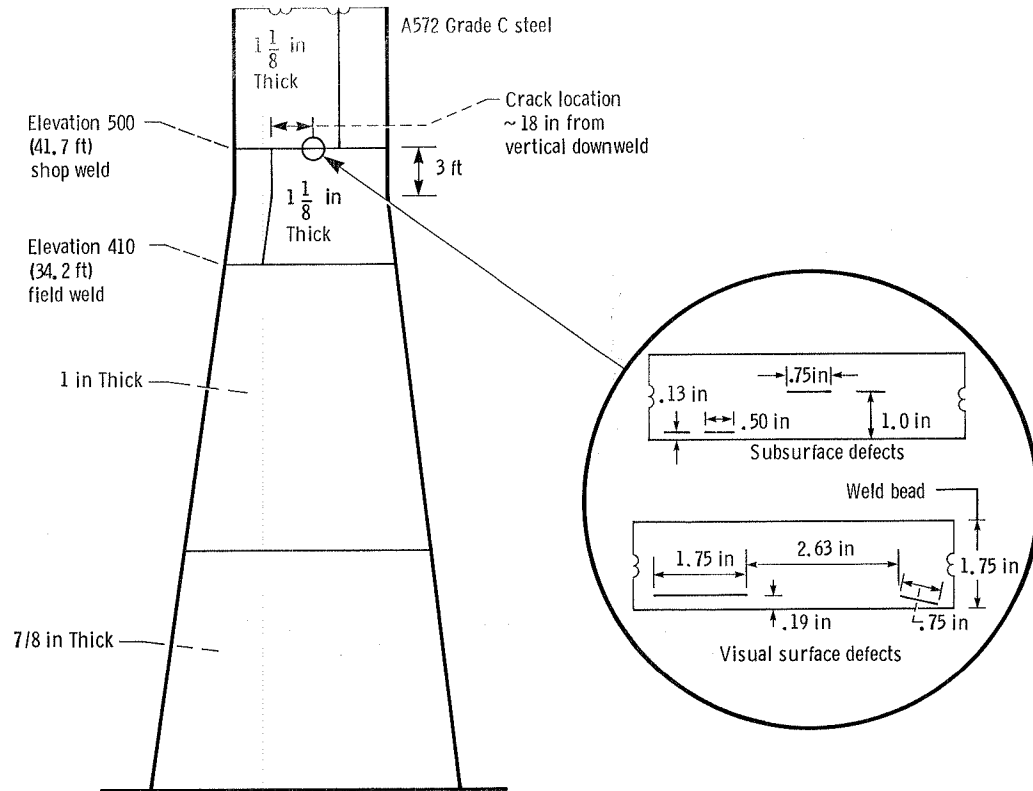
Figure 12. - Solano (WT5) tower crack, view looking east. (Subsurface defects are directly below surface defects.)

Concern: Boeing reported that the WT5 tower had experienced fatigue crack growth from a large slag inclusion located at the 500-in station shop weld. Undetected cracks in the tower could eventually contribute to a catastrophic failure.
